Lake Havasu 2012 Aquatic Plant Monitoring Report

A Final Report Submitted to RNT Consulting and the Central Arizona Project

Geosystems Research Institute Report 4009

April 2013

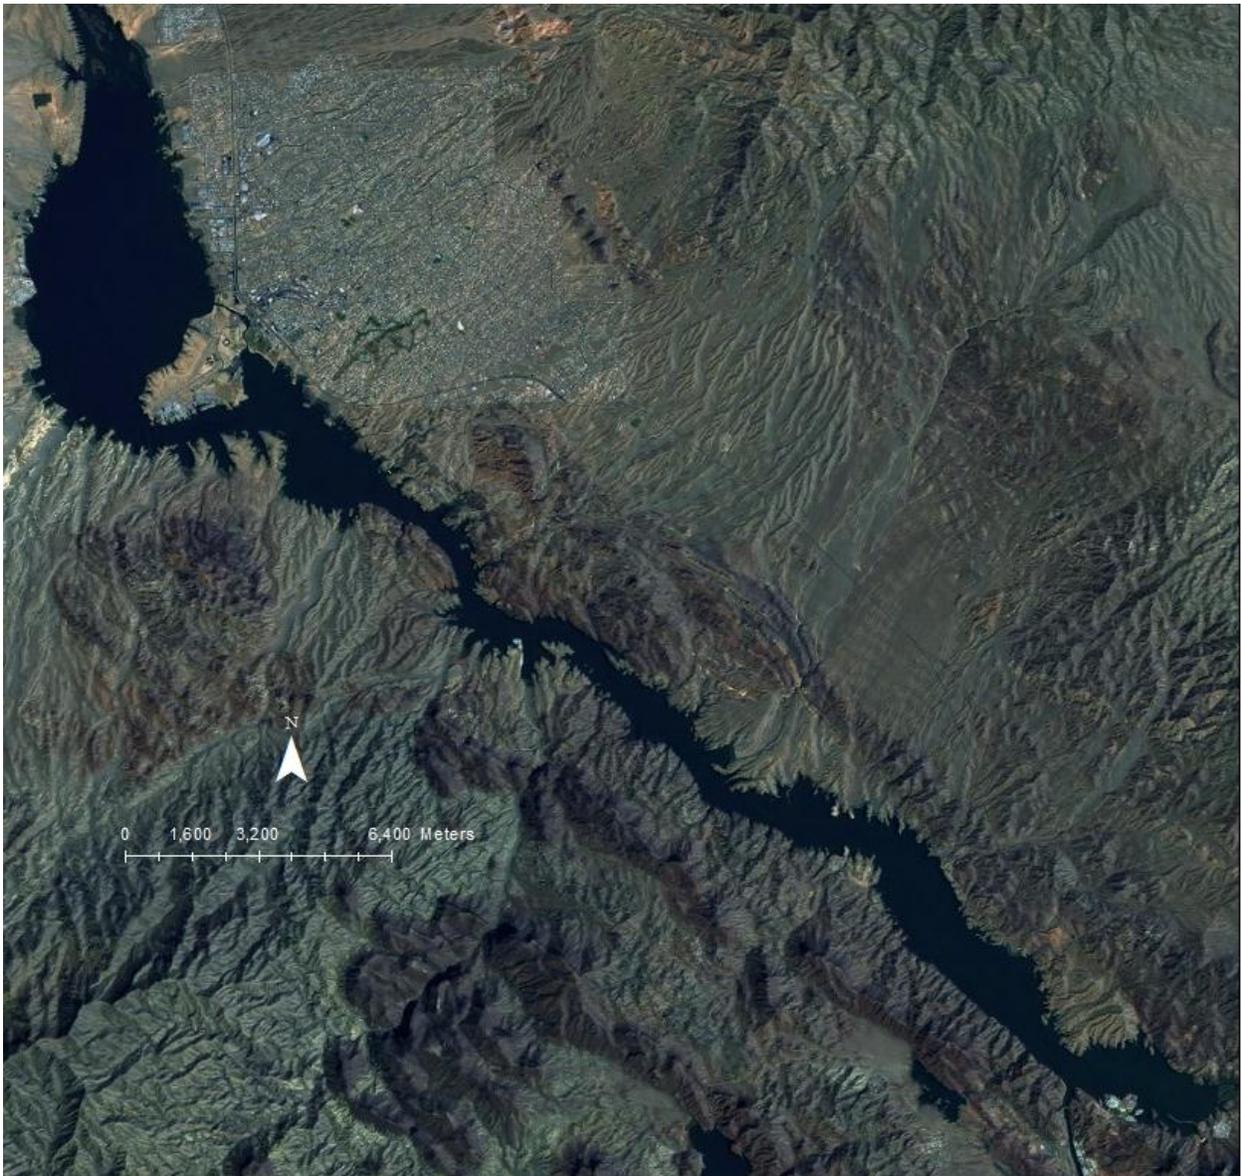
Figure 1. Map of Lake Havasu. The Colorado River inlet is at the northwestern end of the reservoir, and the outlet is near Parker Dam on the southeastern end. Bill Williams NWR enters the southeastern embayment.

Lake Havasu is a 20,400 acre reservoir located on the border of California and Arizona (Figure 1). It was created in 1938 by the construction of Parker Dam on the Colorado River and is the southernmost reservoir in a chain of four reservoirs located on this river (Bureau of Reclamation webpage, www.usbr.gov). In 1973, construction of the Central Arizona Project (CAP) Aqueduct began at Lake Havasu and ended in 1993, south of Tuscon, AZ (Central Arizona Project webpage, www.cap-az.com). The 336 mile aqueduct provides 49.8 billion gallons of water per year to municipal, agricultural, and Native American communities throughout Arizona. Lake Havasu also supplies 1 billion gallons per day of water to Southern California via the Colorado River Aqueduct (Bureau of Reclamation webpage, www.usbr.gov).

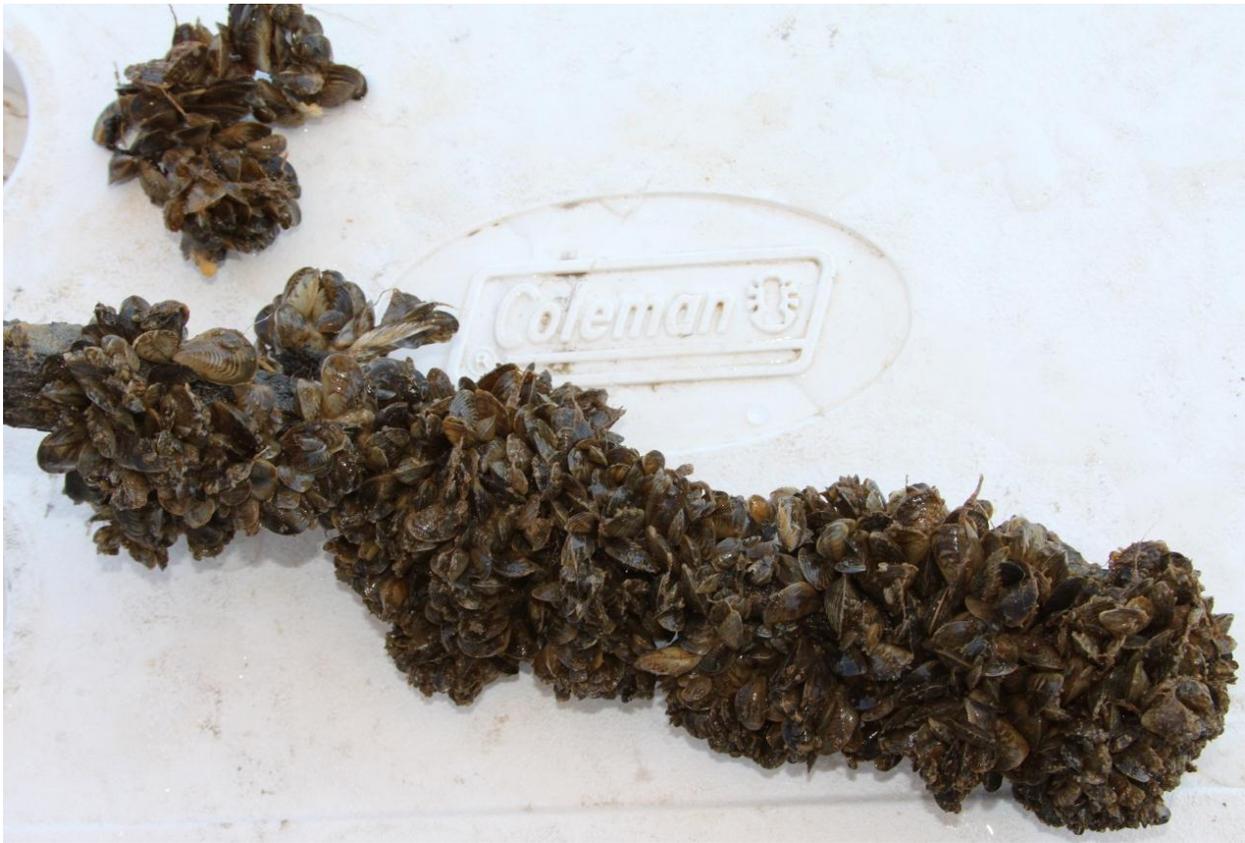
Figure 2. Quagga mussels (*Dreissena rostriformis bugensis*) collected from Lake Havasu in September 2012. Photo by John D. Madsen

In 2007, quagga mussels (*Dreissena rostriformis bugensis*) were discovered in Lake Mead, one of the reservoirs north of Lake Havasu and have since been discovered in Lake Havasu (Figure 2; Central Arizona Project webpage, cap-az.com). In the years following the introduction and establishment of quagga mussels, there has been an increase in the amount of floating dead plant material (Figure 3). These floating mats clog the Mark Wilmer intake pump for CAP. The nuisance vegetation is likely the result of quagga mussels improving water transparency allowing for more light to reach the reservoir floor and promoting plant growth (Madsen et al. 2012). In 2011, a study of the aquatic plant community began to address the nuisance mat problems. In 2012, to further assess the distribution and abundance of the plant community and predict the movement of the plant mats, the point-intercept lake survey and drift study were continued. The results of these studies are presented in this report.

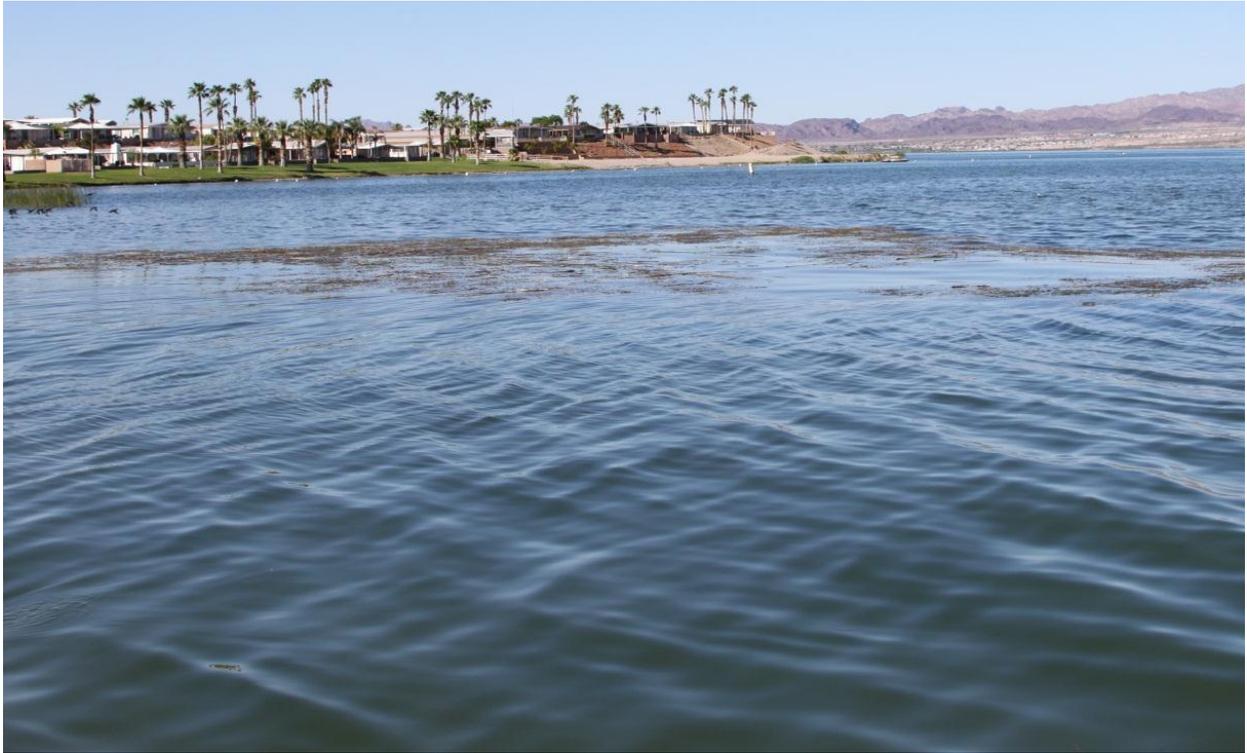
Figure 3. Drifting plant mat in Lake Havasu during August 2012. Photo by John D. Madsen

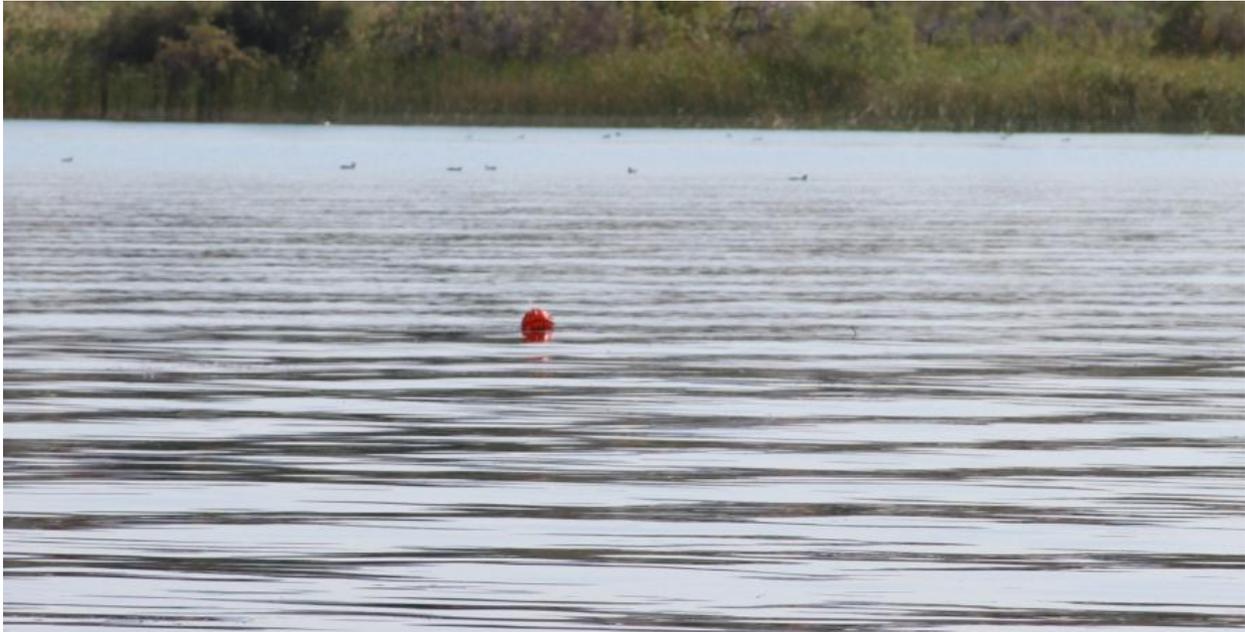
Figure 5. GPS drone drifting in Bill Williams NWR during October 2012. Photo by John D. Madsen.

During October 1-4, 8, and 9 2012, two custom built GPS tracking devices, called drones, were deployed in different areas of Lake Havasu to predict mat drift (Figure 5). On October 1, drift was monitored near the Colorado River inflow. The following five days were focused on the Bill Williams area since it is near the Mark Wilmer pump intake and in the narrow river-like southern section of the reservoir that leads into Bill Williams. During the course of the study, the pumps were not operating to unforeseeable circumstances.

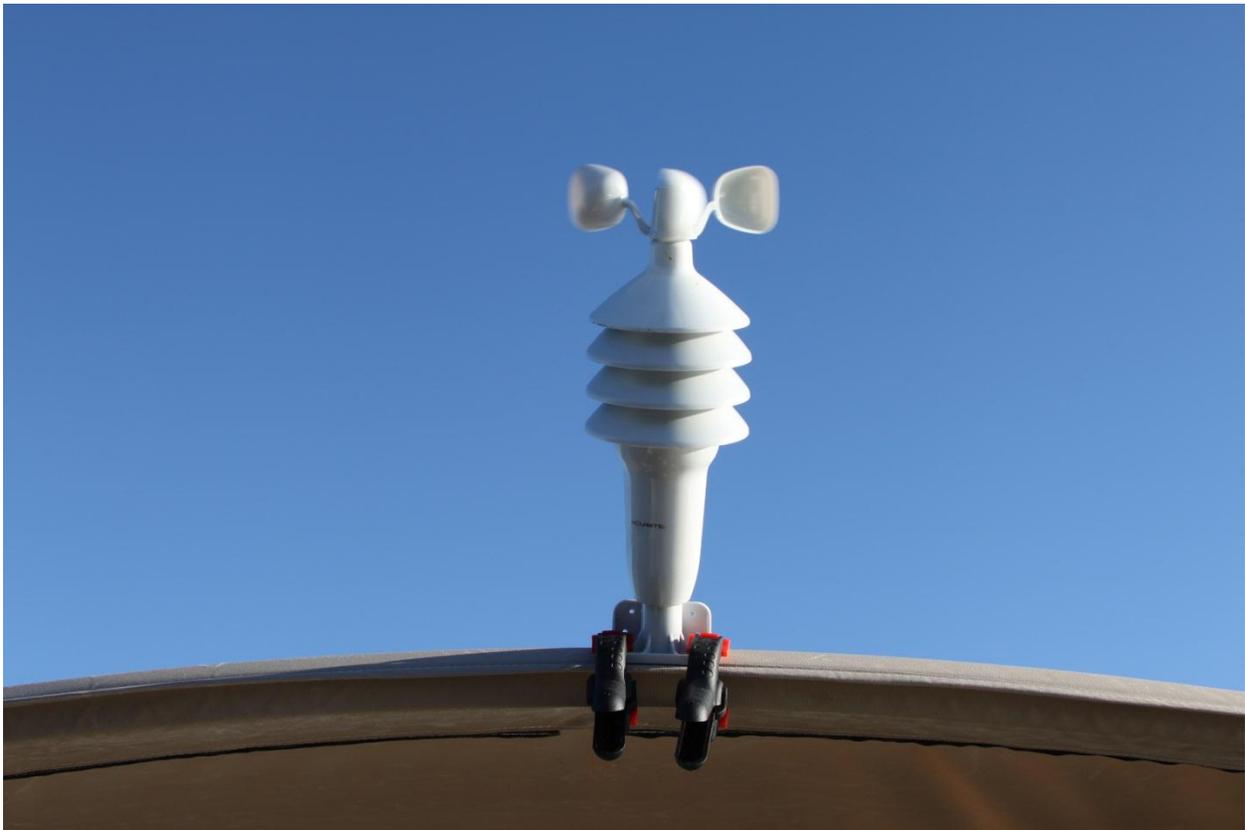
Figure 6. On board weather station that recorded average wind speed. Photo by John D. Madsen.

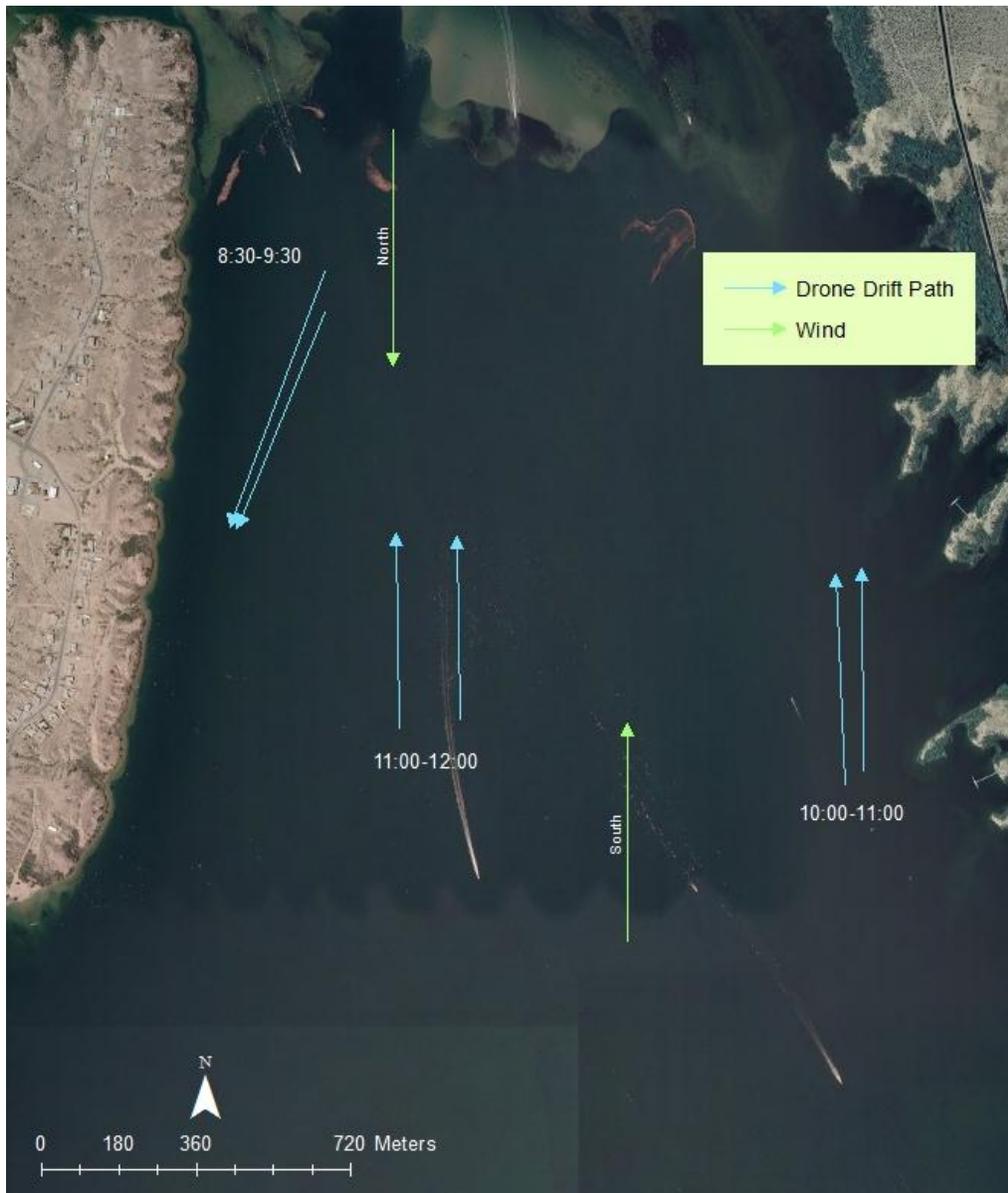
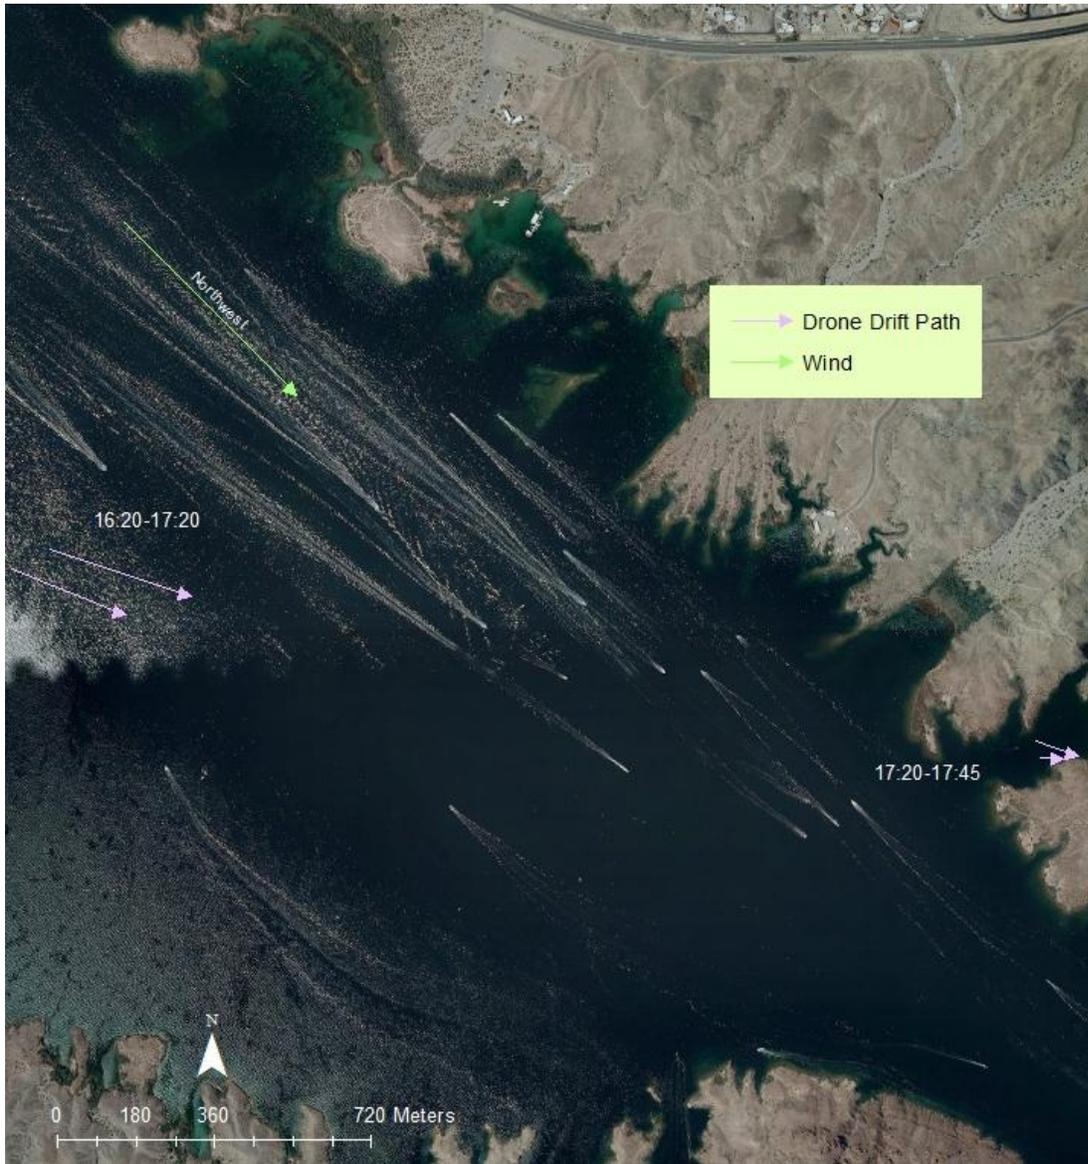
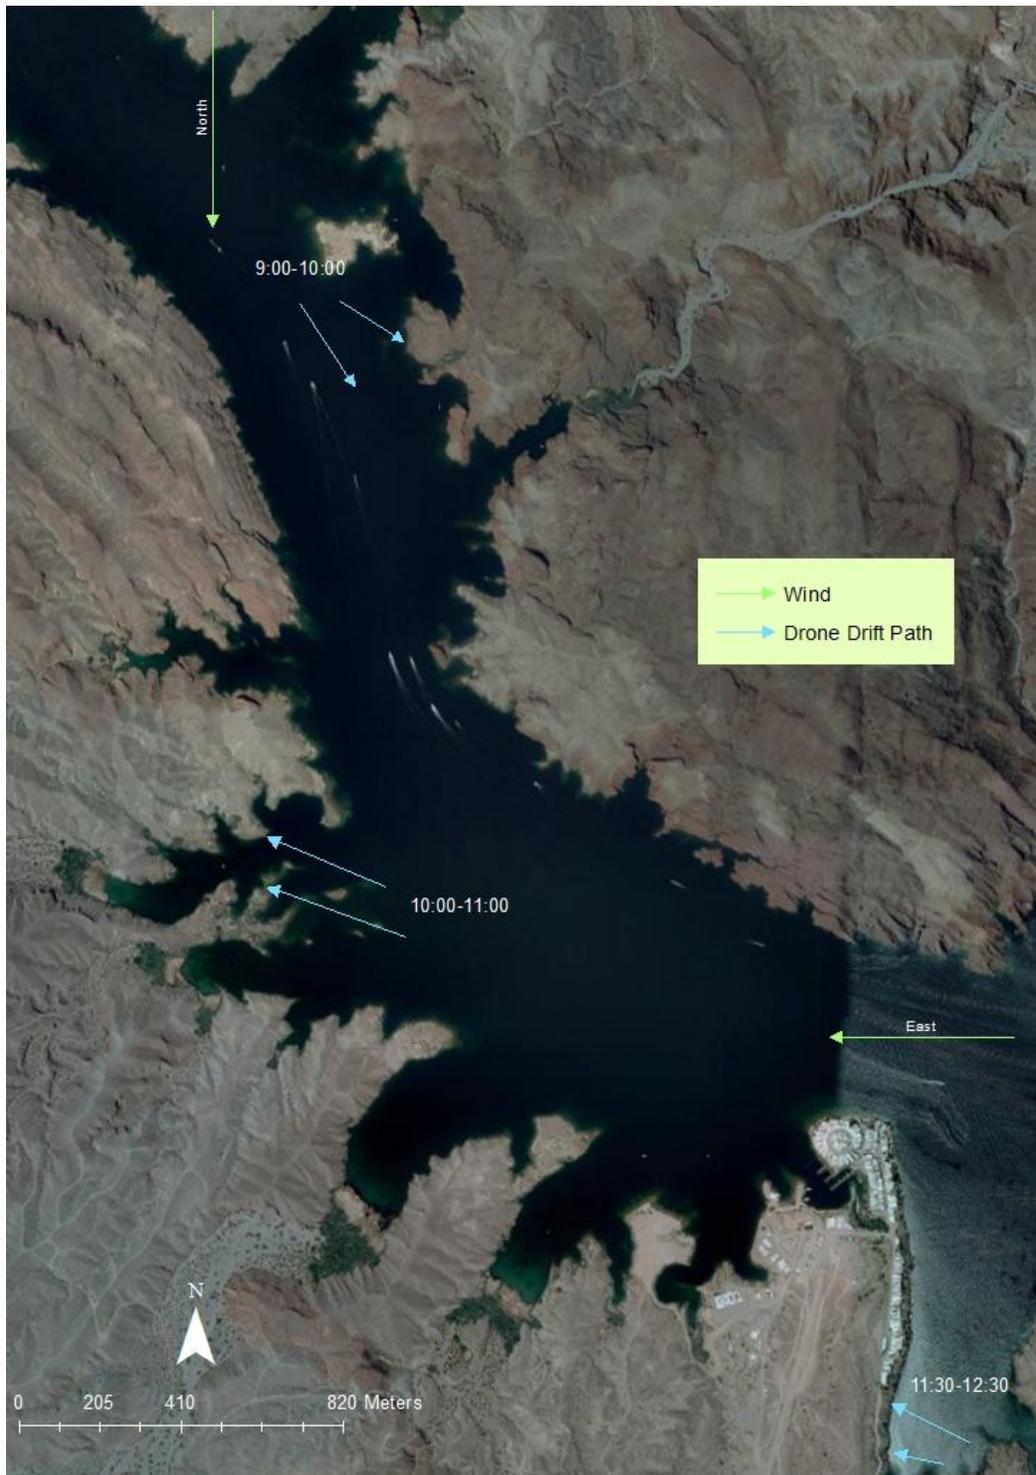
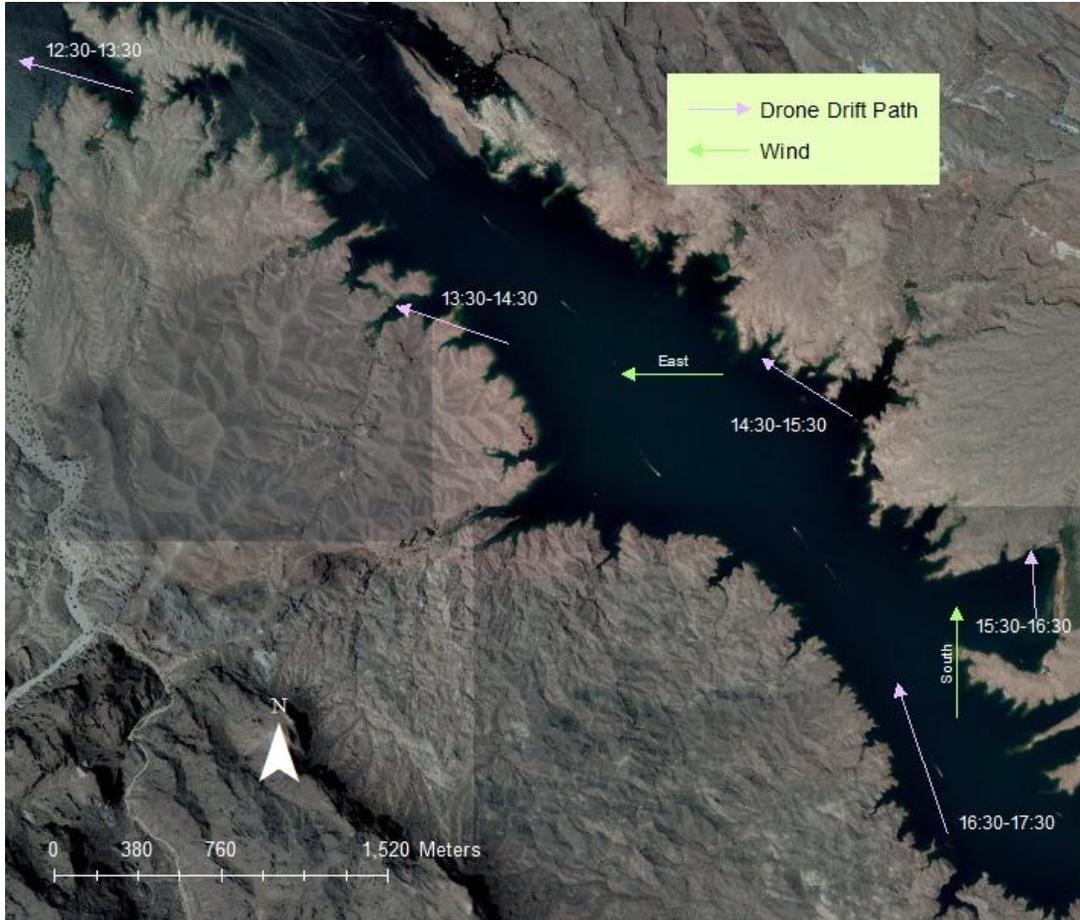
Figure 29. Morning drone drift paths and predominant wind direction observed near the Colorado River inflow in Lake Havasu on October 1, 2012. The length of the arrow tail is the scaled distance the drones traveled.

Figure 30. Afternoon drone drift paths and predominant wind direction observed in the widest section of Lake Havasu on October 1, 2012. The length of the arrow tail is the scaled distance the drones traveled.

Figure 31. Afternoon drone drift paths and predominant wind direction observed near the entrance of the river-like area of Lake Havasu that flows into Bill Williams on October 1, 2012. The length of the arrow tail is the scaled distance the drones traveled.

Figure 33. Afternoon drone drift paths and predominant wind direction observed near the Colorado River Aqueduct intake pump on October 2, 2012. The length of the arrow tail is the scaled distance the drones traveled.

Figure 35. Morning drone drift paths and predominant wind direction observed in river-like area of Lake Havasu that flows into Bill Williams NWR on October 3, 2012. The length of the arrow tail is the scaled distance the drones traveled.

Figure 36. Morning drone drift paths and predominant wind direction observed in river-like area of Lake Havasu that flows into Bill Williams NWR on October 3, 2012. The length of the arrow tail is the scaled distance the drones traveled.

Figure 37. Afternoon drone drift paths and predominant wind direction observed in river-like area of Lake Havasu that flows into Bill Williams NWR on October 3, 2012. The length of the arrow tail is the scaled distance the drones traveled.

Figure 39. Afternoon drone drift paths and predominant wind direction observed near the Colorado River Aqueduct on October 4, 2012. The length of the arrow tail is the scaled distance the drones traveled.

Figure 41. Morning drone drift paths and predominant wind direction observed in the river-like area of Lake Havasu that flows into Bill Williams on October 8, 2012. The length of the arrow tail is the scaled distance the drones traveled.

Figure 42. Afternoon drone drift paths and predominant wind direction observed in the river-like area of Lake Havasu that flows into Bill Williams on October 8, 2012. The length of the arrow tail is the scaled distance the drones traveled.

Figure 44. Afternoon drone drift paths and predominant wind direction observed near the Colorado River Aqueduct intake pump on October 9, 2012. The length of the arrow tail is the scaled distance the drones traveled.

predominant wind. As illustrated in the drone drift maps, the drones move with the wind (Figures 29-45). On average, the drones also moved farther in the afternoon than in the morning (Table 4).

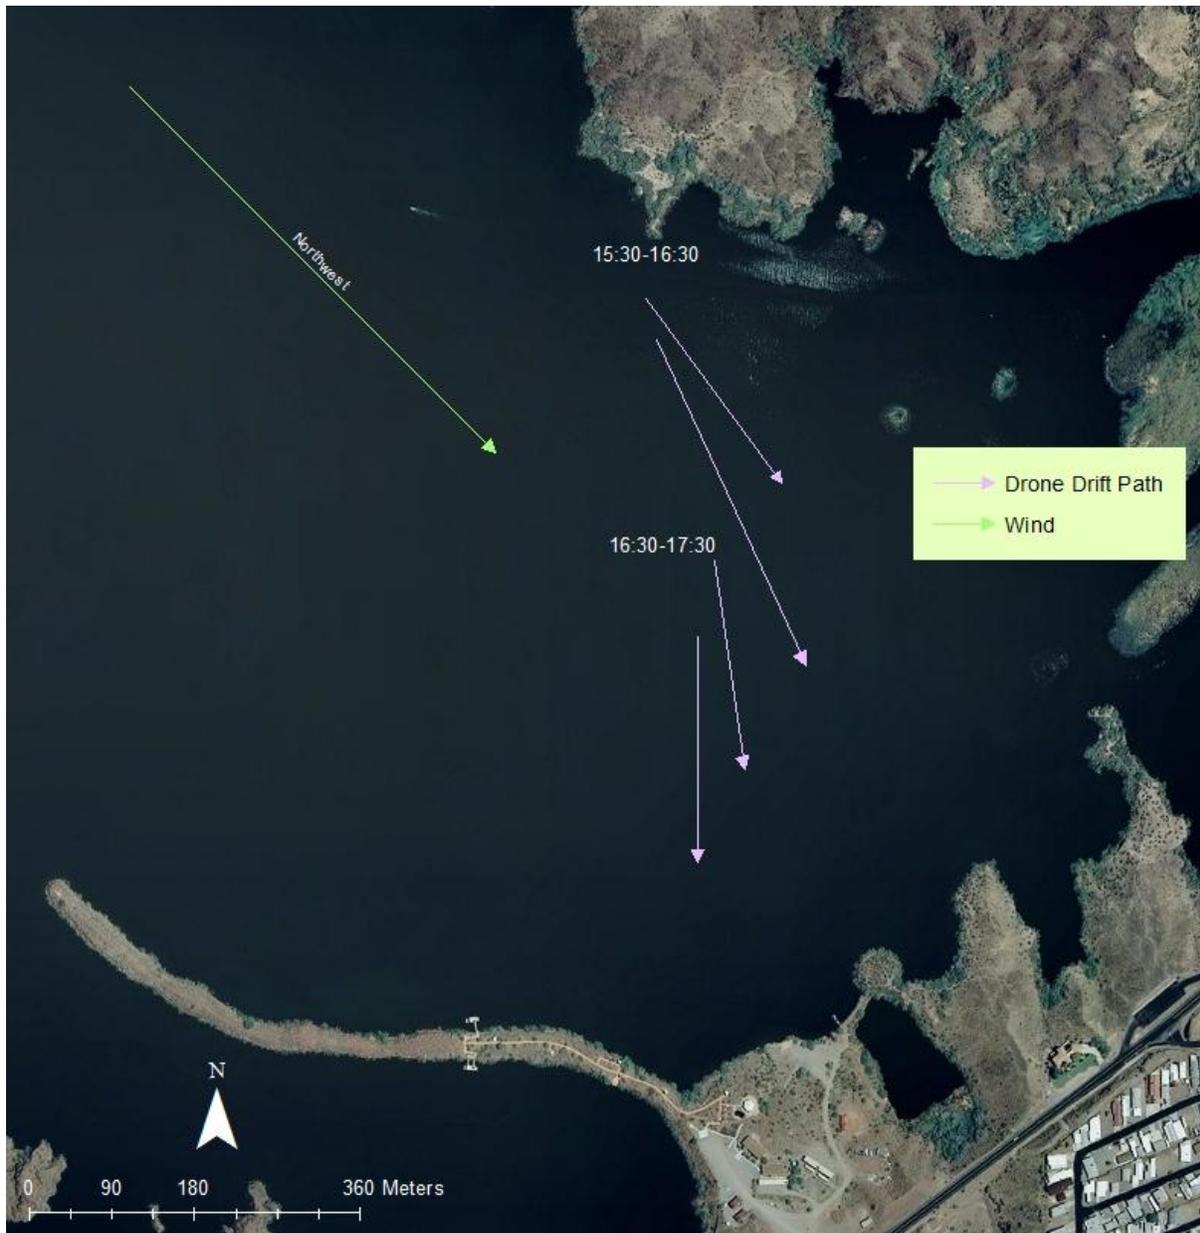
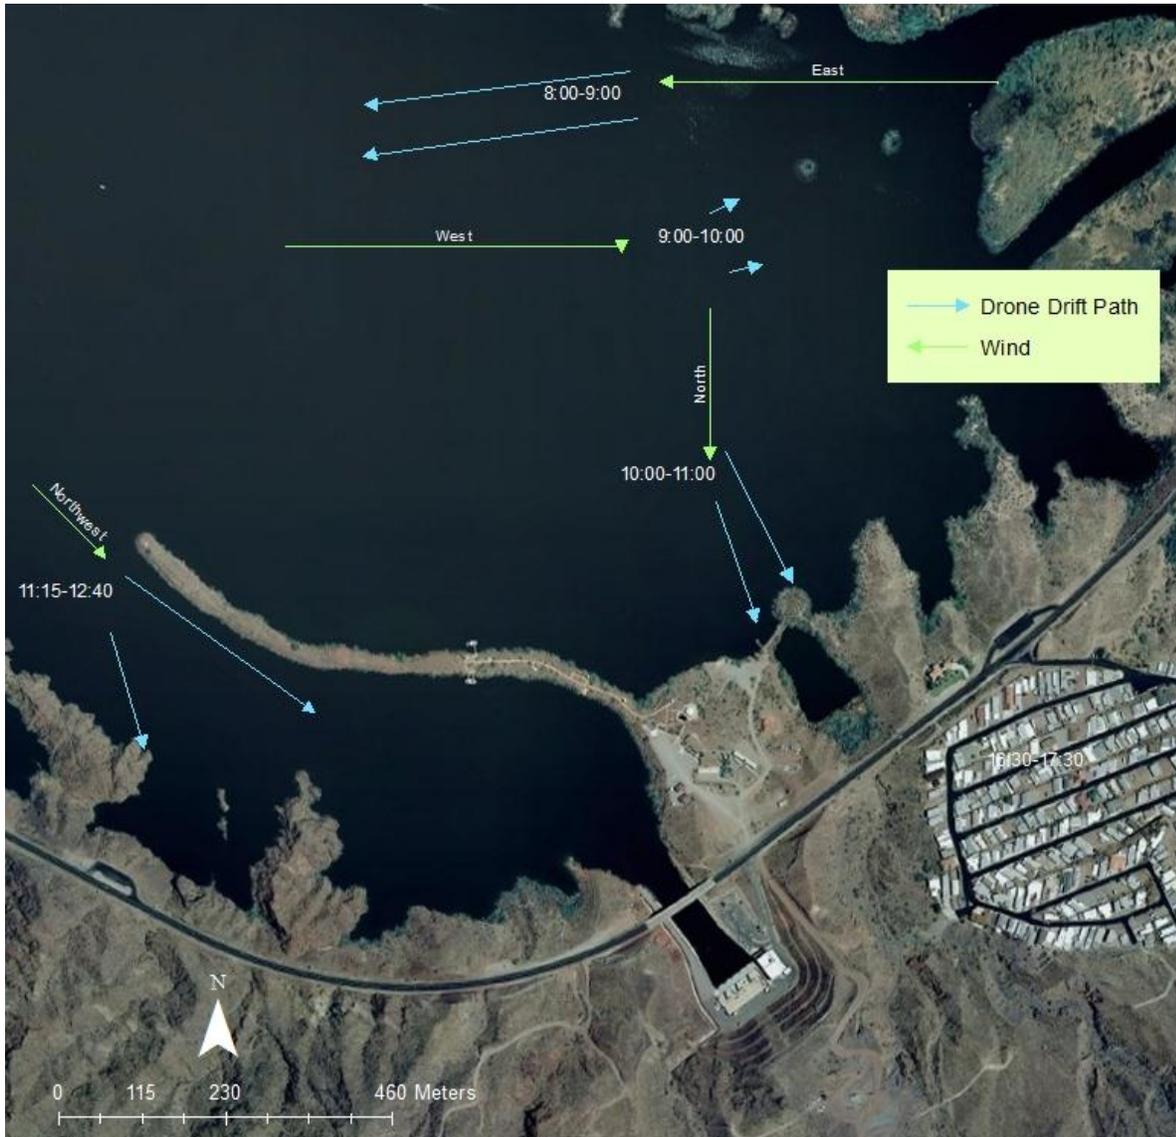
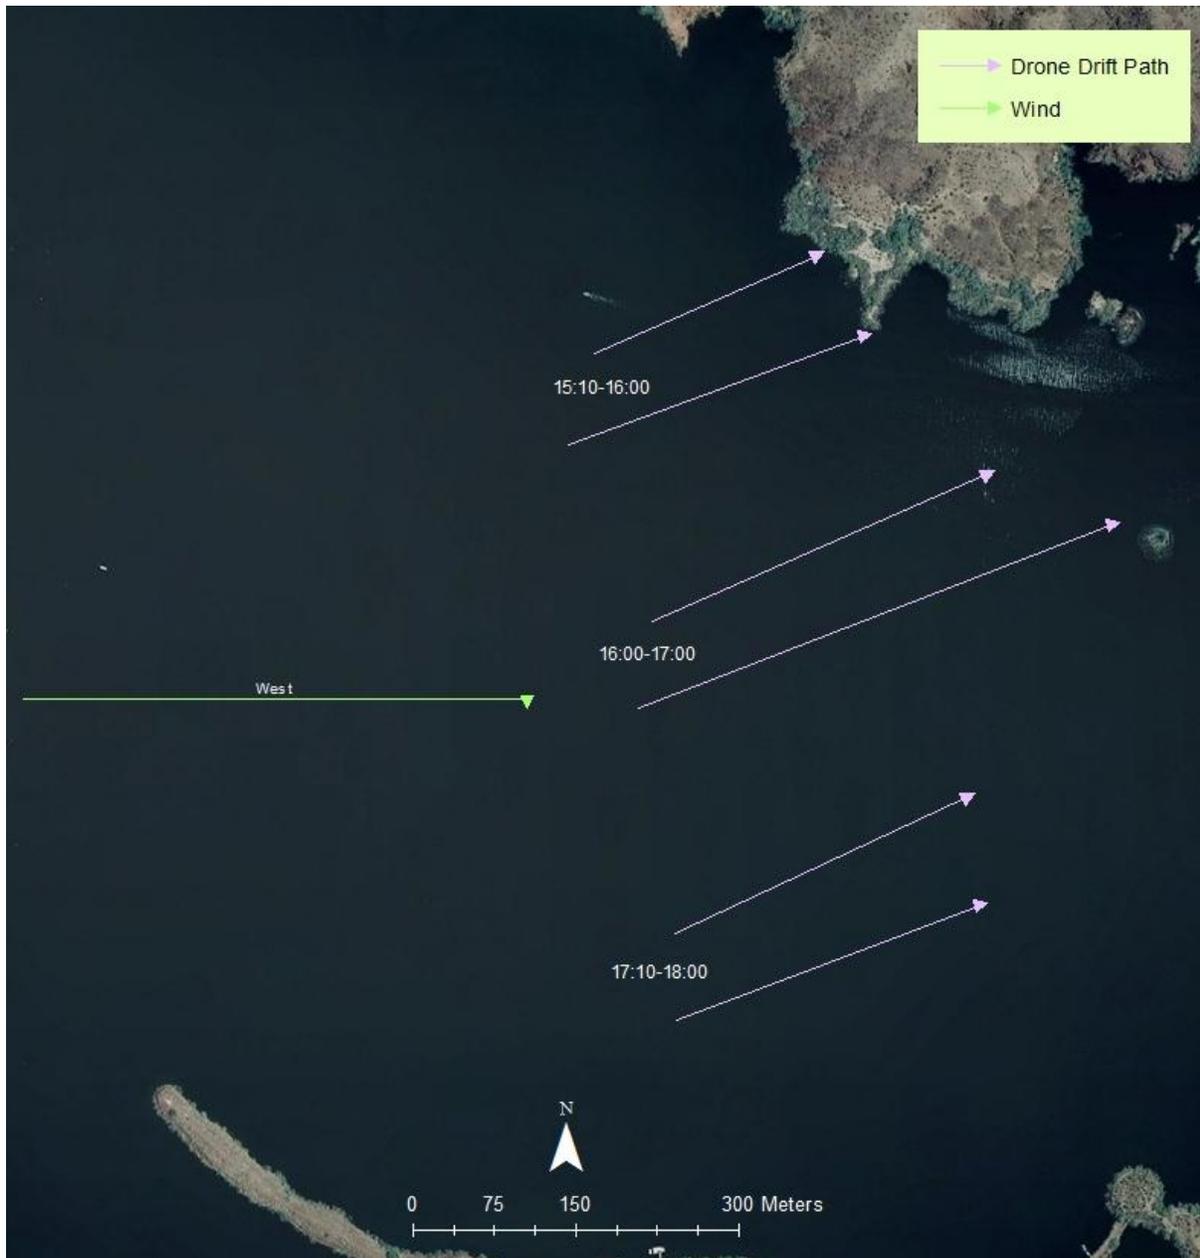
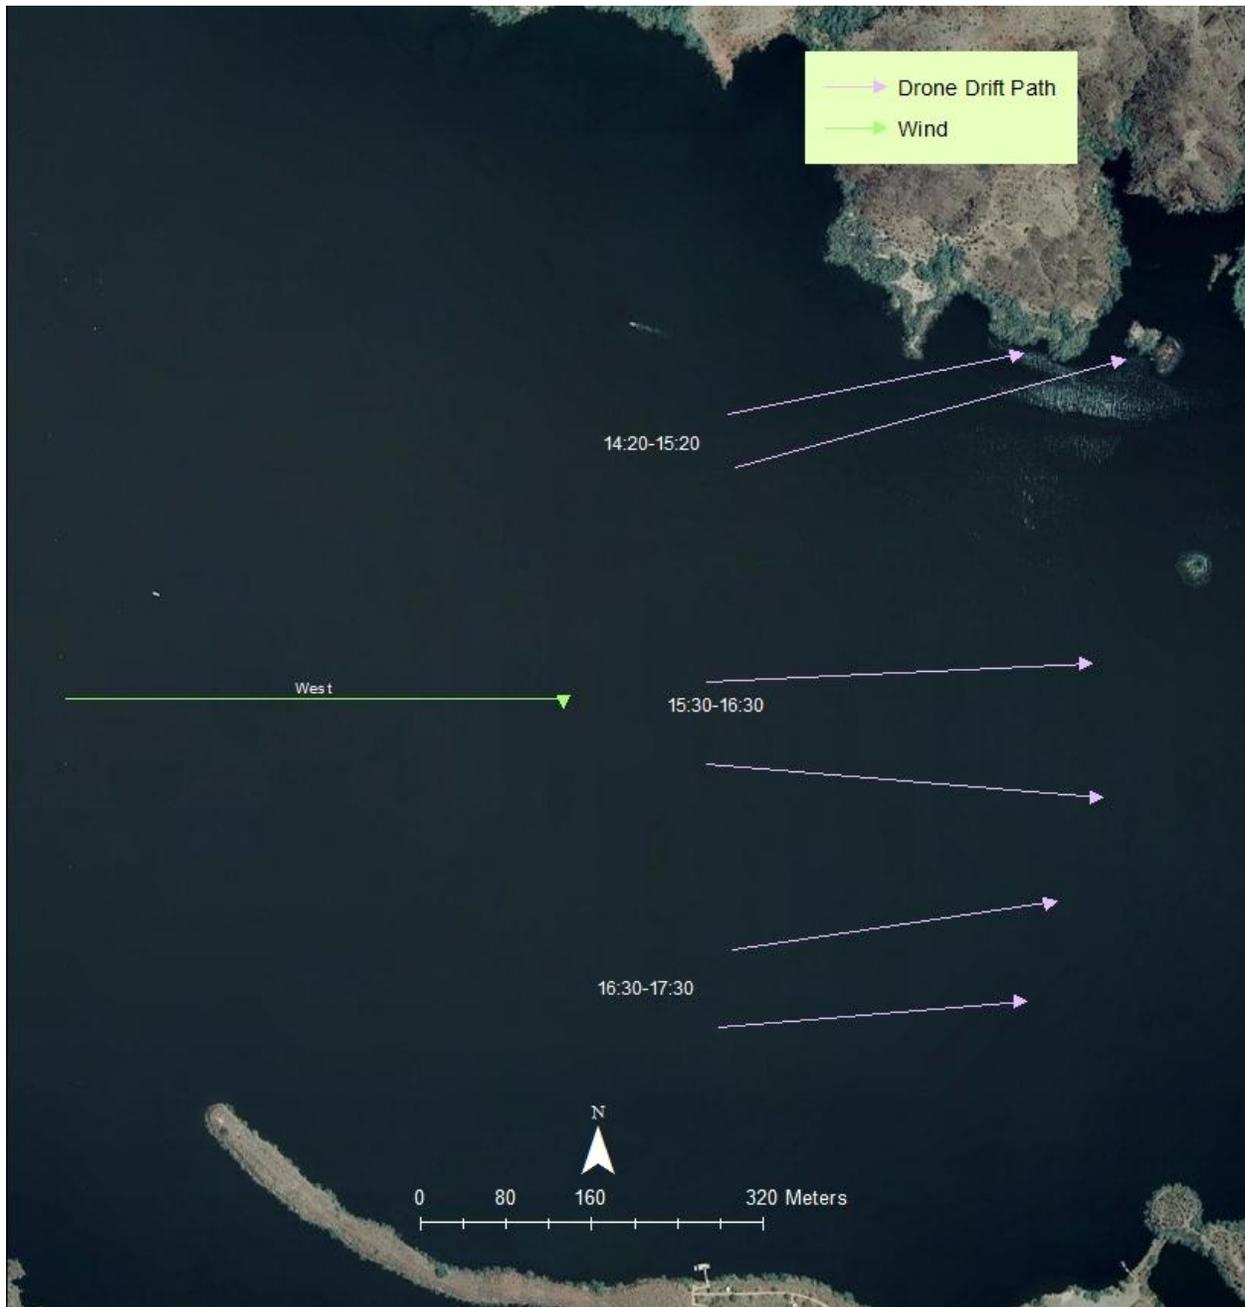
Figure 32. Morning drone drift paths and predominant wind direction observed in Bill Williams NWR on October 2, 2012. The length of the arrow tail is the scaled distance the drones traveled.

Figure 34. Afternoon drone drift paths and predominant wind direction observed in Bill Williams NWR on October 2, 2012. The length of the arrow tail is the scaled distance the drones traveled.

Figure 38. Morning drone drift paths and predominant wind direction observed in Bill Williams NWR on October 4, 2012. The length of the arrow tail is the scaled distance the drones traveled.

Figure 40. Afternoon drone drift paths and predominant wind direction Bill Williams NWR on October 4, 2012. The length of the arrow tail is the scaled distance the drones traveled.

Figure 43. Morning drone drift paths and predominant wind direction observed in Bill Williams NWR on October 9, 2012. The length of the arrow tail is the scaled distance the drones traveled.

Figure 45. Afternoon drone drift paths and predominant wind direction observed in Bill Williams NWR on October 9, 2012. The length of the arrow tail is the scaled distance the drones traveled.

During our study in the Bill Williams area, similar drift patterns were observed every morning and afternoon (Figures 32-34, 38-40, 43-45). At the first release of the day, typically around 7:30am, the wind would be from the east, southeast or northeast. This would generate a westward drift path. By 9:30, the winds would shift and originate from the west or northwest. Subsequently, drone drift path would shift accordingly. In September and October, the predominant wind direction is from the west which our field observations support (Windfinder webpage, Windfinder.com).
